Boletim Especial de Aeronavegabilidade (*Special Airworthiness Bulletin*)

BEA Nº 2023-01

Date: February 10th,

Subject: Rotary Switches Pull-to-Turn Feature inspection

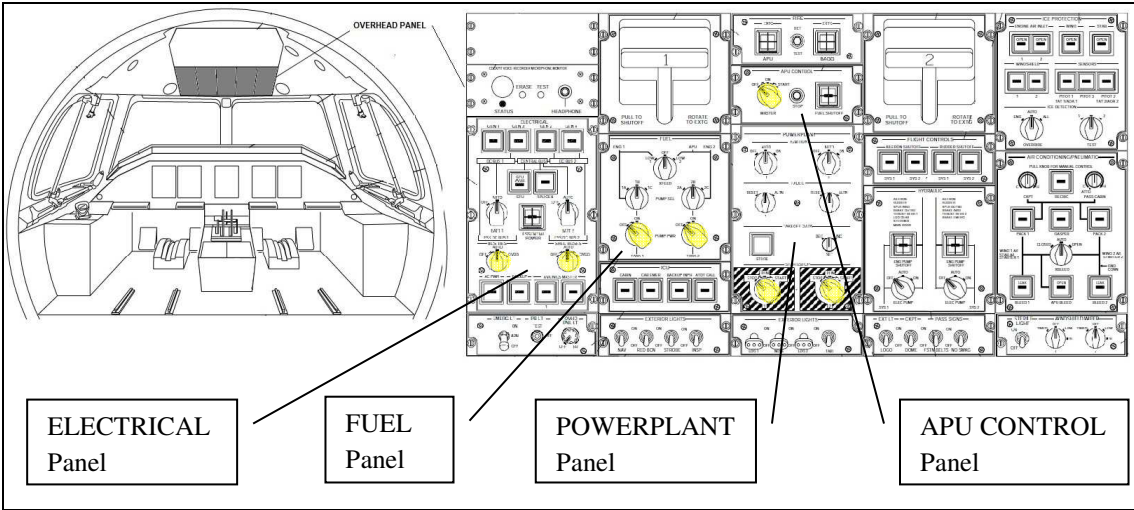
- 1- Visually inspect the panel face markings adjacent to the rotary switches identified in Table 2 below (see Figures 1 through 5 below for the locations of the switches for each aircraft family – Table 2 switches are highlighted in yellow), for obscured / erased paint markings. Ensure that the panel markings are clearly visible and legible. Obscured / erased panel markings can prevent the crew to accurately set the switch to the position intended;

Figure 1 – EMB-135/145 Overhead Panel (typical) – Relevant switches are highlighted

If any of the switches listed in Table 2 have unreadable / obscure / erased markings, and/or if there is no need to pull the switch first before turning them, replace the discrepant switch.

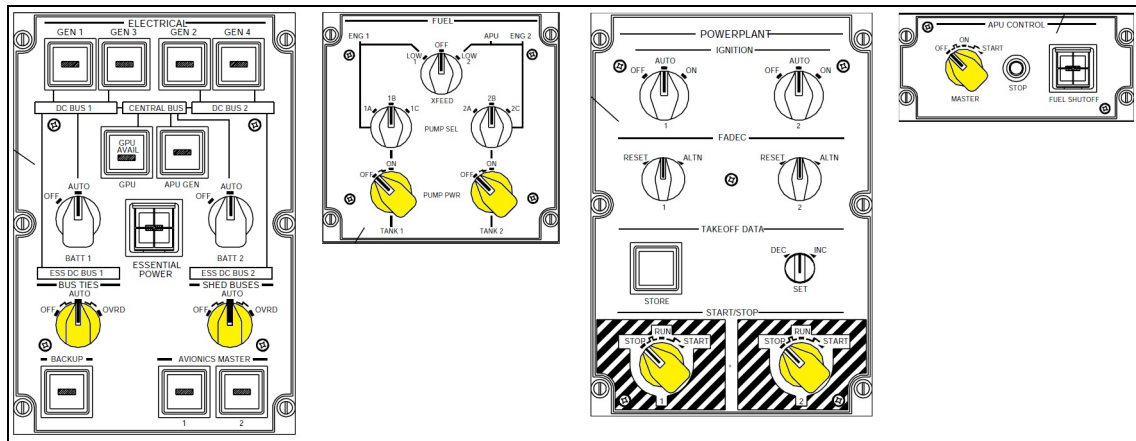
Figure 2 – EMB-135/145 Panel Detailing (typical) – Relevant switches are highlighted

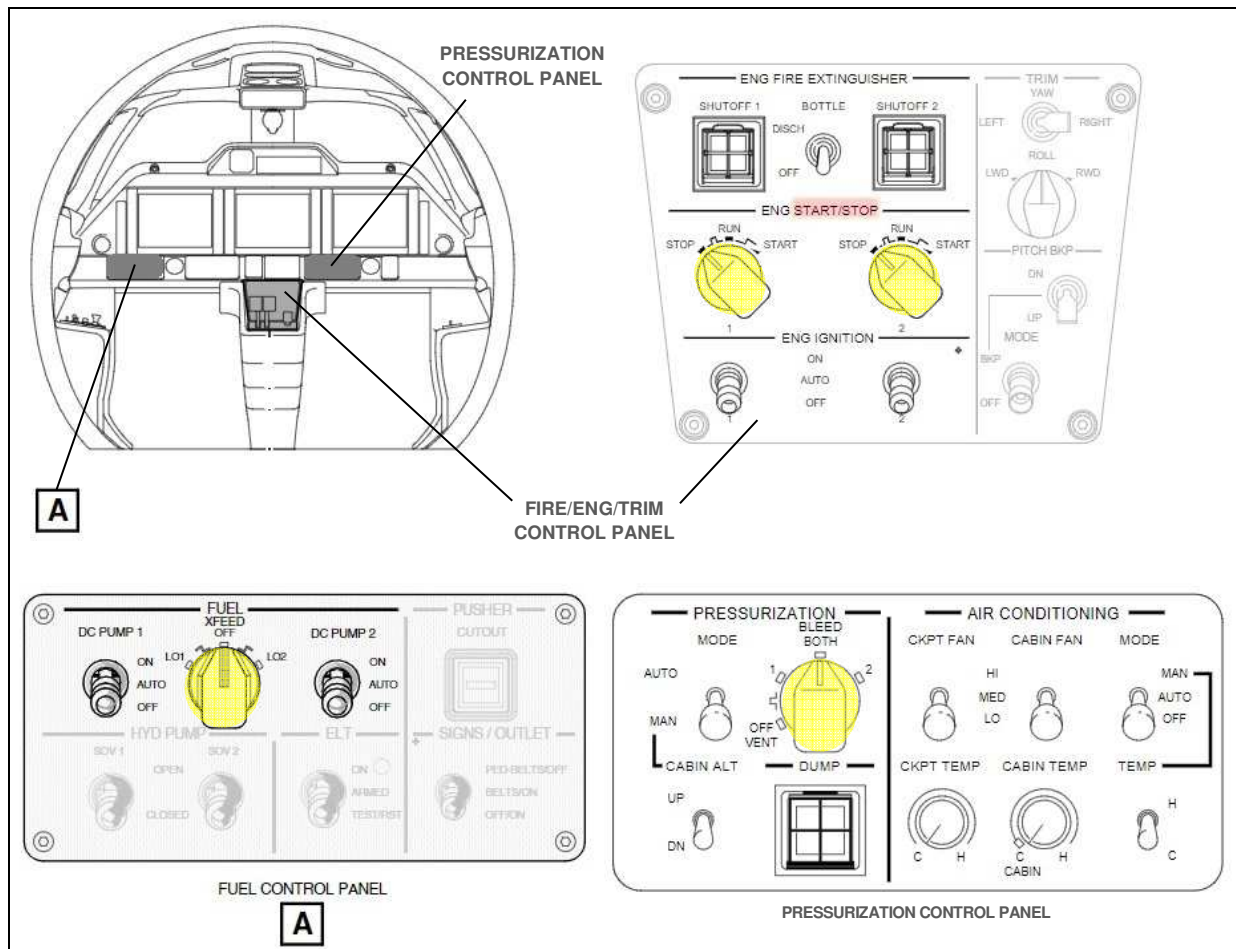
Figure 3 – EMB-500/505 Panels (typical) – Relevant switches are highlighted

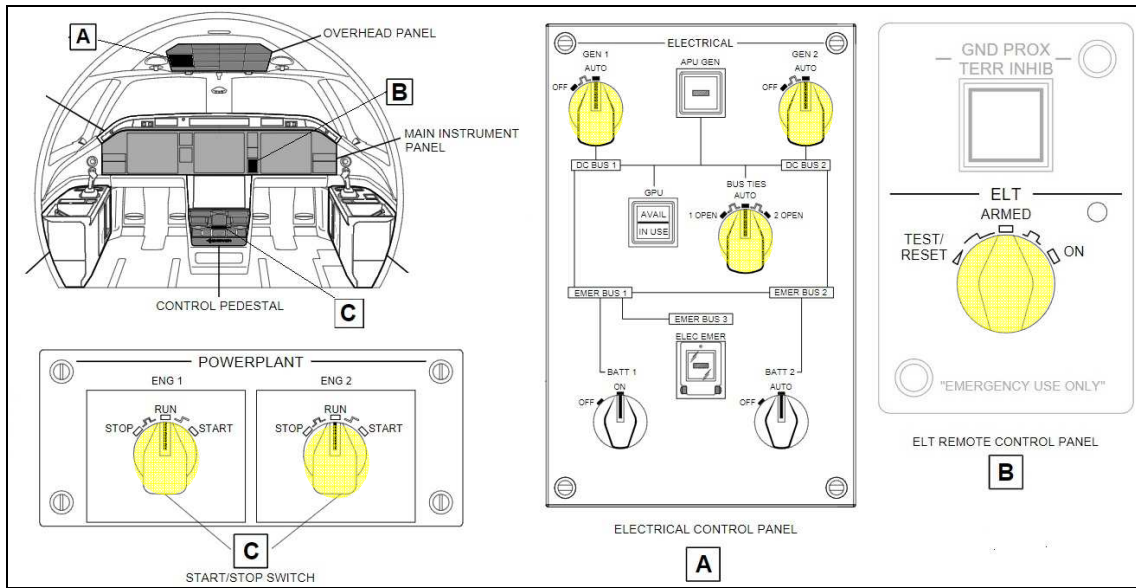
Figure 4 – EMB-545/550 Panels (typical) – Relevant switches are highlighted

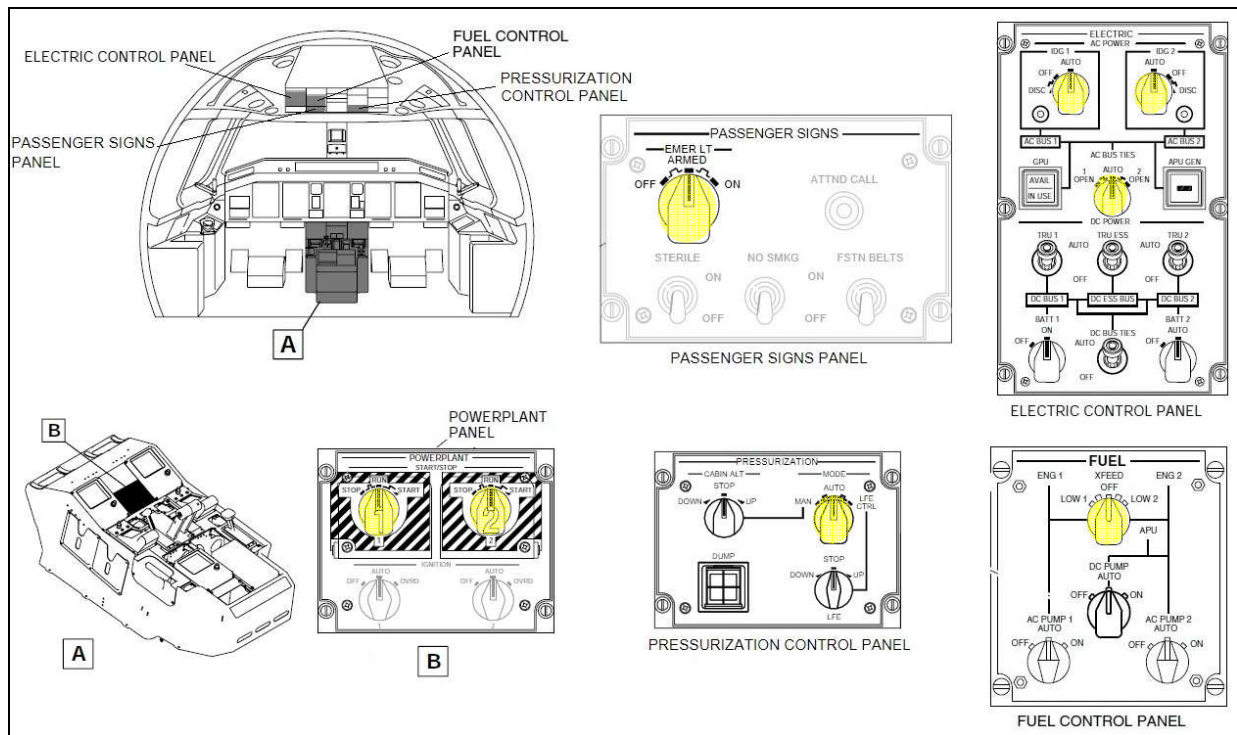
Figure 5 – ERJ-170/190 Panels (typical) – Relevant switches are highlighted

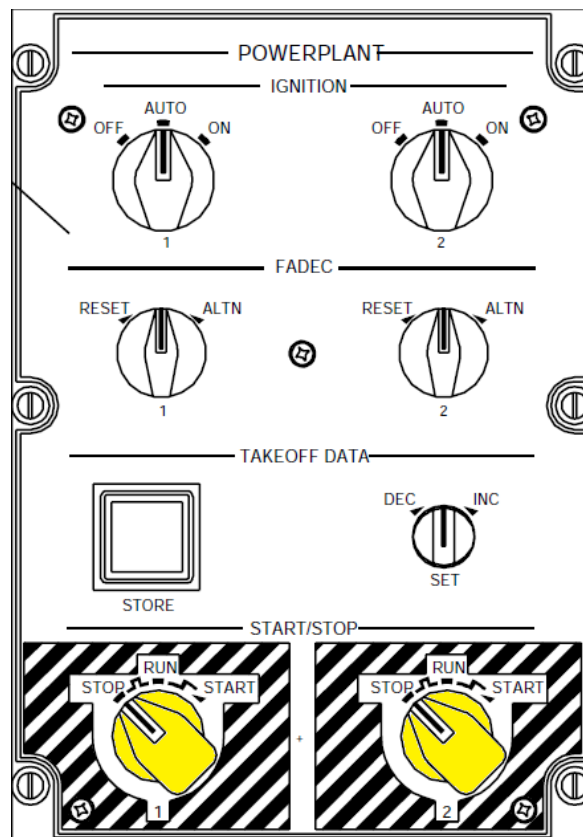
Figure 6 – EMB-135/145 Powerplant panel (typical) – Engine Start/Stop switches are highlighted

- a) Set the switch (see Figures 6 and 7 above) to the initial position indicated in Table 3 below:

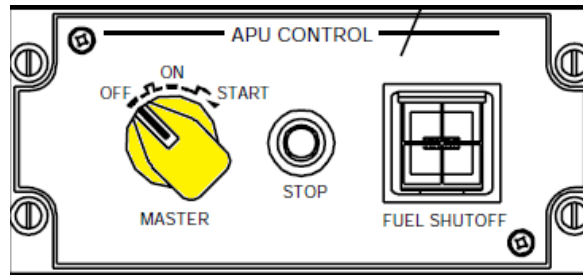
Figure 7 – EMB-135/145 APU Control panel (typical) – APU Master switch is highlighted
