Boletim Especial de Aeronavegabilidade *(Special Airworthiness Bulletin)*

ATA: 21 – Air Conditioning System

BEA N° 2020-09

Subject: Manual Pressurization System Controller knob **Date:** August 10th, 2020
inspection

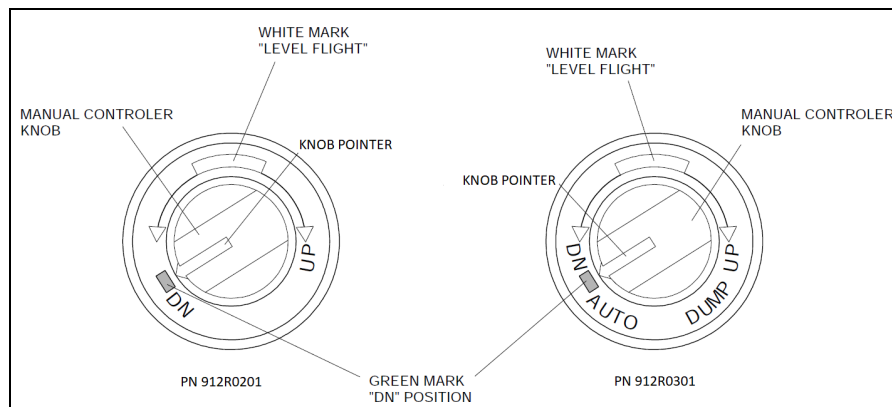
- 1- Visually inspect the manual pressure controller knob and panel face markings in the cockpit for obscured / erased paint markings. Ensure that the knob pointer line and panel face markings are clearly visible and legible. Panel face or controller knob obscured / erased markings can prevent the crew to accurately set the manual pressurization system;

- 2- Do a check of the manual controller knob (PNs 912R0201 or 912R0301, see Figure 1 below) as follows:
 - a) Make sure that the engines and APU are not in operation;

- b) Turn the manual controller knob fully clockwise. When the knob pointer line approaches the 4 o'clock position ("UP" marking on the panel face), a detent spot (notch) should be felt in the movement of the knob;

- c) Turn the manual controller knob fully counterclockwise. When the knob pointer line approaches the 8 o'clock position ("DN" or "DN AUTO" green marking on the panel face, depending on PN 912R0201 or 912R0301, respectively), a detent spot (notch) should be felt in the movement of the knob.

If unreadable / obscured / erased markings are identified in the visual inspection, or if too much force is required to turn the knob or if either of the detent spots are not felt, replace the part.
