Panorama of Prevention and Investigation of Aeronautical Accidents

AERONAUTICAL ACCIDENT INVESTIGATION AND PREVENTION
CENTER - CENIPA

Col Andre Luiz MOTA - Head of Investigation Subdivision

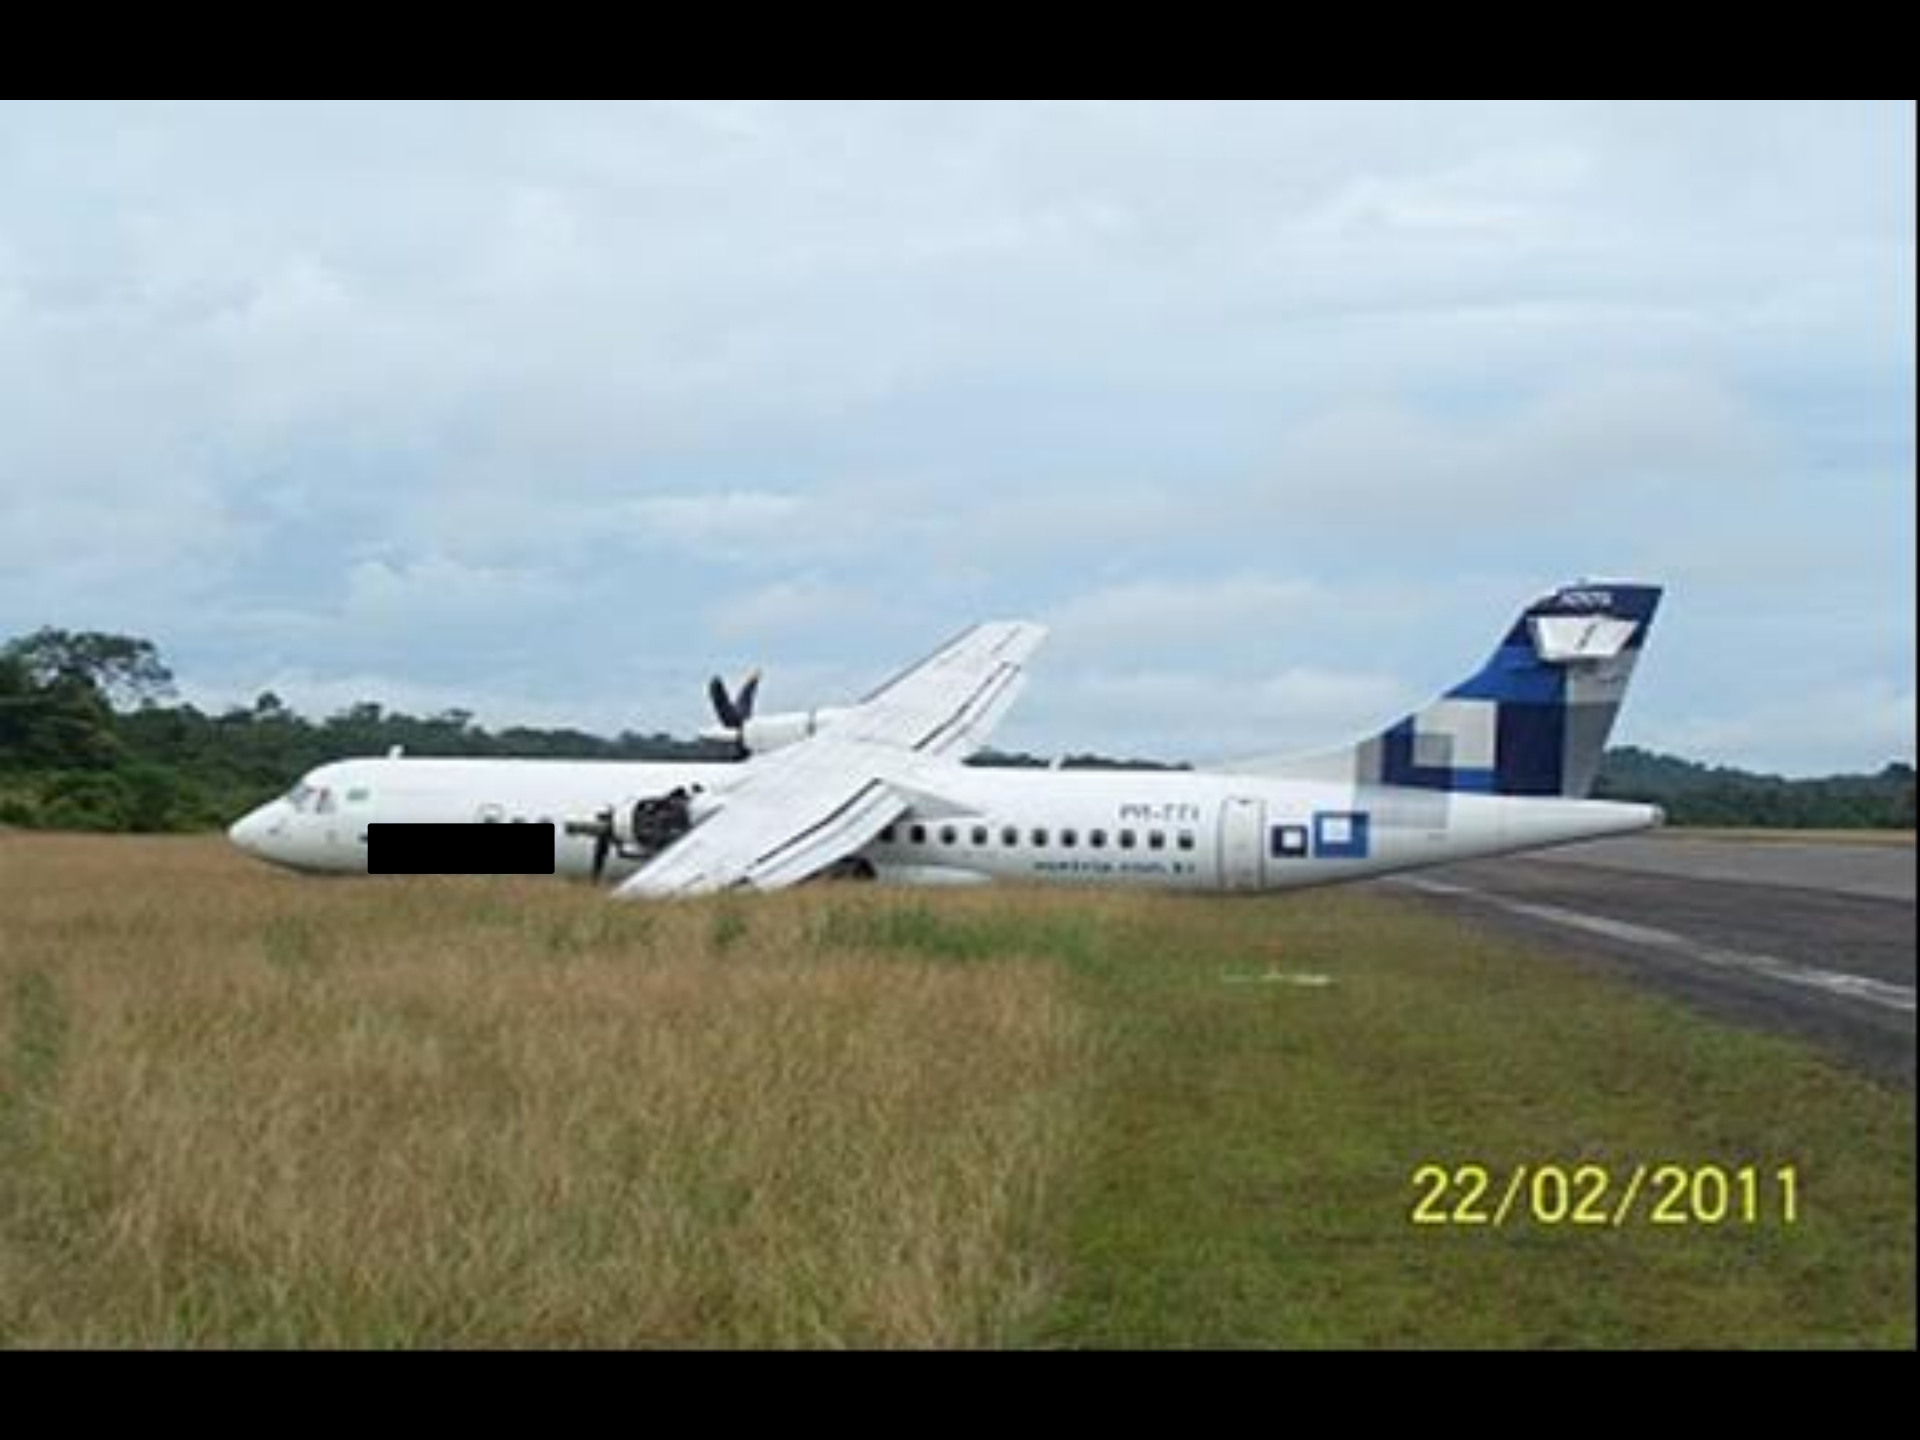
ATR 72-212

- The aircraft departed from SBBE on an IFR flight plan, destined for SBHT.
- The approach for landing in SBHT was visual and stabilized. The touchdown on the runway was smooth, with gradual deceleration, in which only the “ground idle” was utilized.
- After the “70kt” callout, a strong noise was heard, and the left main gear collapsed, with the aircraft veering off to the left. The aircraft exited the runway and came to a stop in a grass area.
- There were 46 passengers and 4 crew members on board. One of the passengers suffered minor injuries.
- There was no damage to third parties.

- During the PR-TTI landing roll, the left main landing gear collapsed, as a result of the fracture of the AFT PIVOT PIN (D61000 SN 25). According to the aircraft manual, the entire landing gear must be overhauled after every eight-year period or 18,000 cycles.

- During the investigation, it was found that, despite being a workshop structured to perform machining services and other types of repairs, two of the subcontracted companies neither possessed nor made use of the aircraft manuals when doing the services discussed in this report. Thus, it failed to comply with the established parameters and limits when machining the AFT PIVOT PIN (D61000 E1 SN 25).

- According to the pin maintenance manual there was no plan for any type of machining in the pin section transition region. The resulting inadequate machining finish in the region served as a facilitator for the onset of the fatigue process in the pins.
- Despite the prescriptions contained in the maintenance company's MPI, there was no participation and/or supervision by any of its professionals. This fact, jeopardized the safety of the flight.
- In the case of the outsourced companies, the required methods, techniques and parameters were not observed for the reasons previously commented, namely: lack of manuals, as well as lack of skill and knowledge in relation to the characteristics of the maintenance of certified aeronautical products.

- The last point* in the chain of events leading to the accident (*active failure) was the nonuse of the manufacturer's manuals in some stages of the overhaul of the LEFT MAIN LANDING GEAR ASSEMBLY (PN D23189000-19 SN MN170), in particular in the services performed in the AFT PIVOT PIN (D 61000 E1 SN 25). However, before this active failure, a series of actions had functioned as latent conditions.

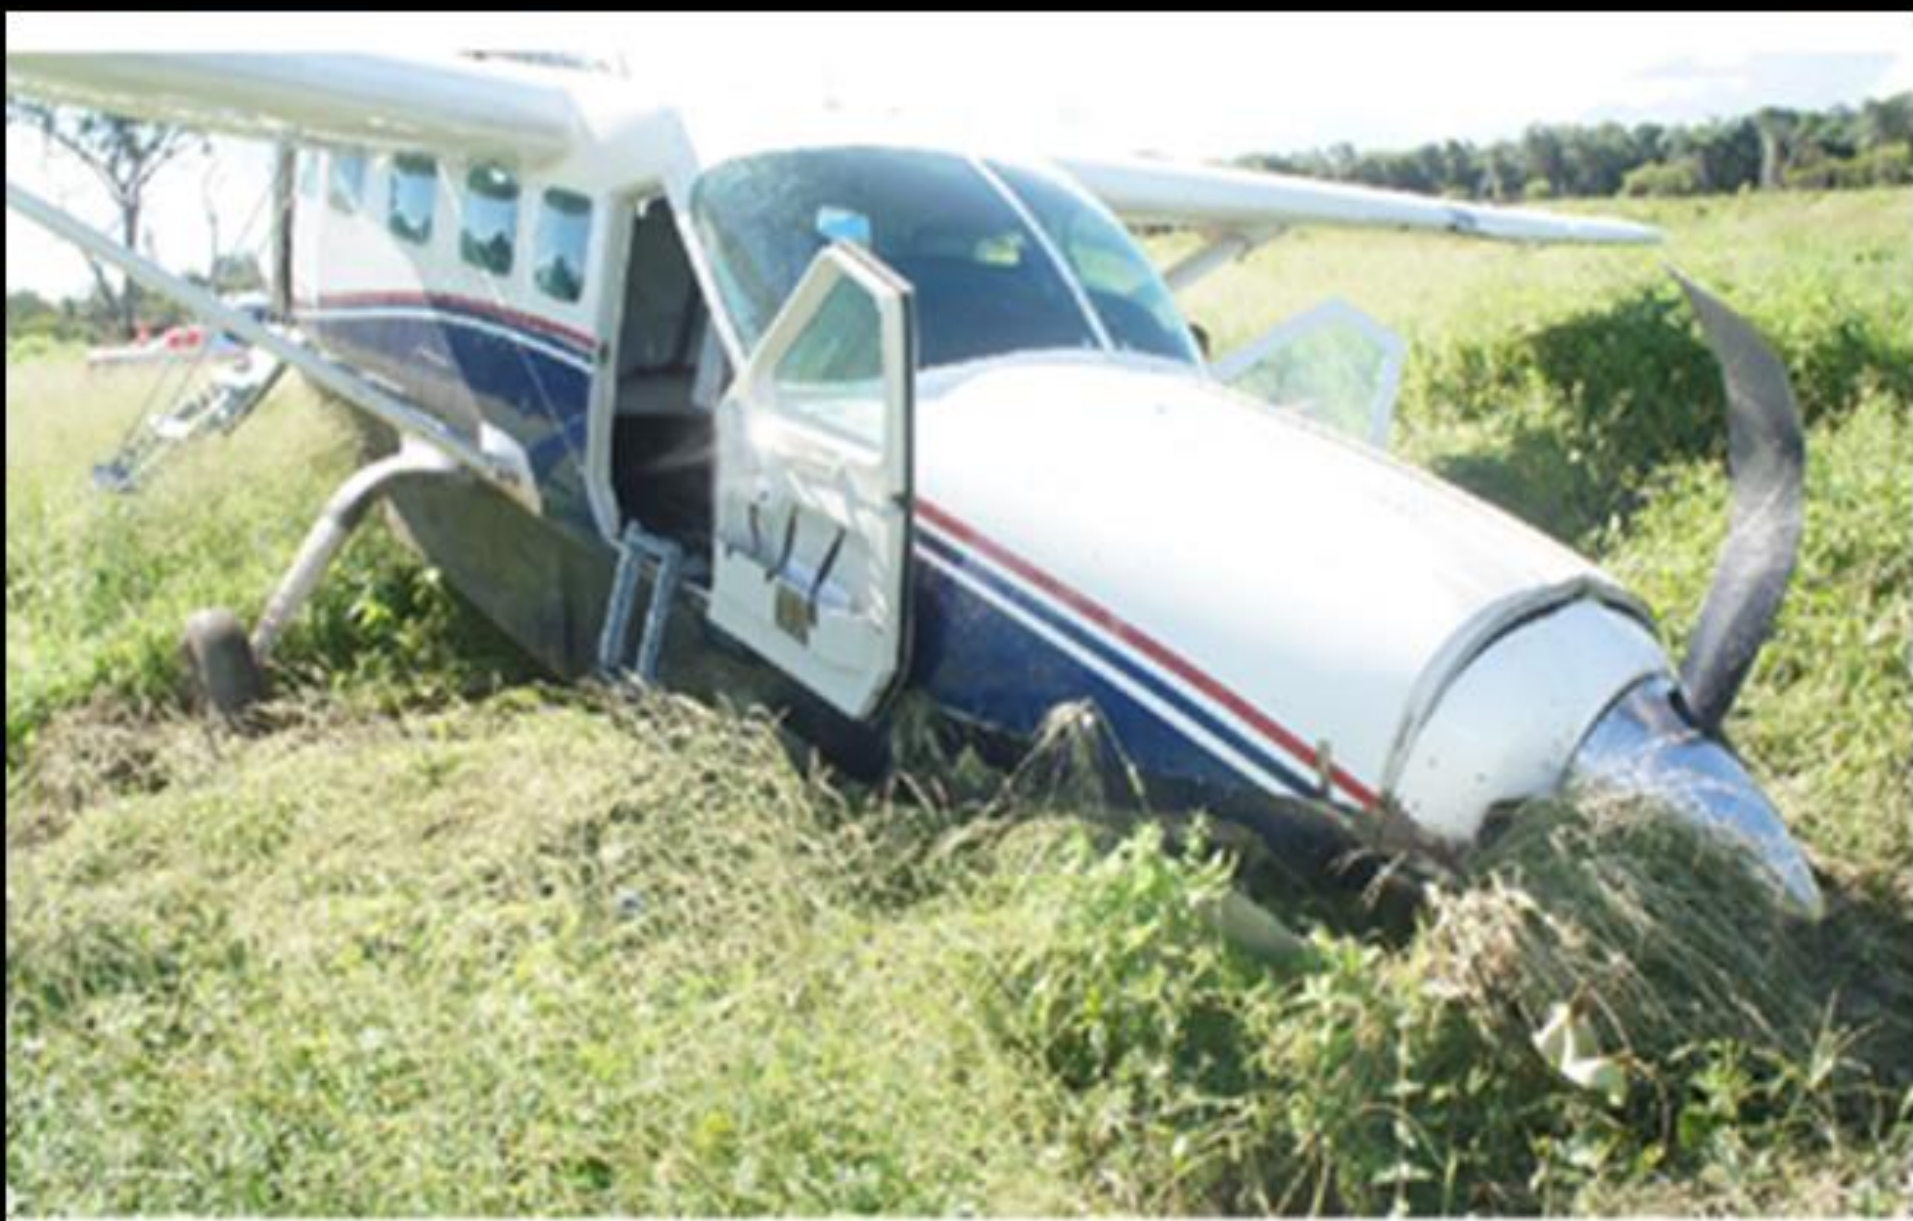
CESSNA 208B
PR-CRF
04APR2016

- The aircraft took off from Alberto Alcolumbre International Airport – AP (SBMQ), to the Monte Dourado Aerodrome - PA (SBMD), at 1010 (UTC), in order to transport cargo and personnel, with two pilots and three passengers on board.
- During take-off, while the plane was cruising at approximately 1,800 feet altitude, there was a sudden loss of power with subsequent engine shutdown.
- According to the statements made, there was an attempt to turn on the engine again, without success.
- Faced with this condition, the aircraft was conducted to make a forced landing on an unprepared area, about 3NM from threshold 08 of SBMQ.
- After touching the ground, the plane traveled about 100 meters to the full stop and had the nose gear separated on that route.
- The aircraft had substantial damage. The pilot, the co-pilot and two passengers were unharmed. One passenger suffered minor injuries

- According to the report presented by DCTA to the investigators, the high working pressure of the fuel in the transfer tube caused a displacement from its housing, since the latch plate that was supposed to hold it and to avoid its movement was deformed.
- Thus, the instant the seal ring approached the entrance of the body of that injector nozzle, a fuel leak occurred, since that seat had a conical shape.
- As the pressure in the power line decreases, the engine nozzles cease to function, resulting in loss of power.
- The displacement of the transfer tube was possible because the igniter cable wire, at the 4 o'clock position, had been anchored on its latch plate. When the wire was pulled too far, it lifted and deformed this plate.
- As a result, the fuel transfer tube has been free to move from its correct working position.

- Thus, the deformation of the latch plate of the transfer tubes, which allowed its displacement, probably occurred during the execution of this safety wired. It was characterized the inadequacy of maintenance services performed on the aircraft as a contributing factor to the failure of the PR-CRF engine.
