Abnormal runway contact during takeoff

- Abnormal runway contact during takeoff under heavy rain at Durango Airport, Mexico

EMB-190 31/Jul/2018

Embraer Air Safety Department

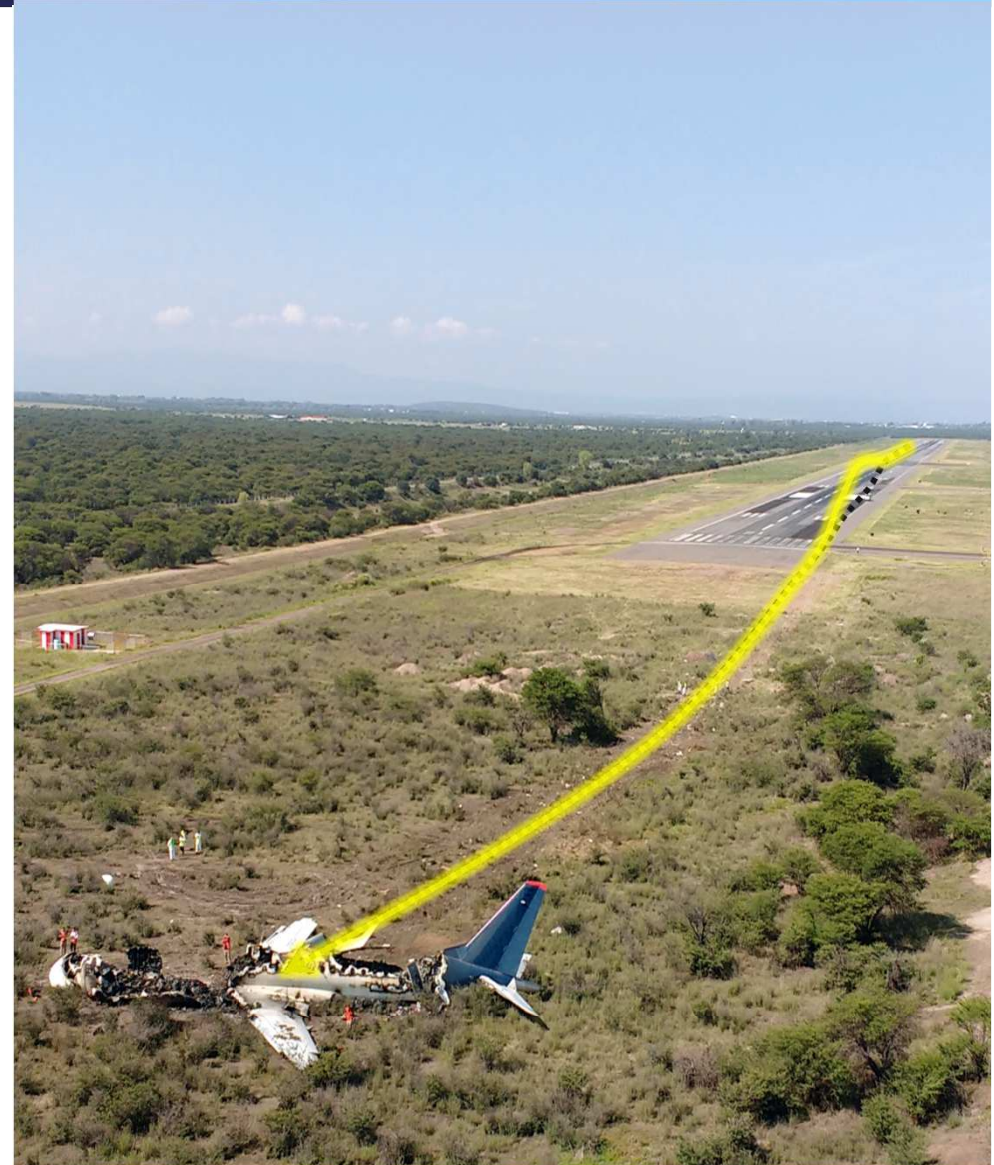
- The aircraft experienced an **abnormal** runway contact **during takeoff** under **heavy rain** at Durango Airport, Mexico.
- **103** POB, **NO** fatalities:
 - **14** severe
 - **25** light
 - **64** not injured

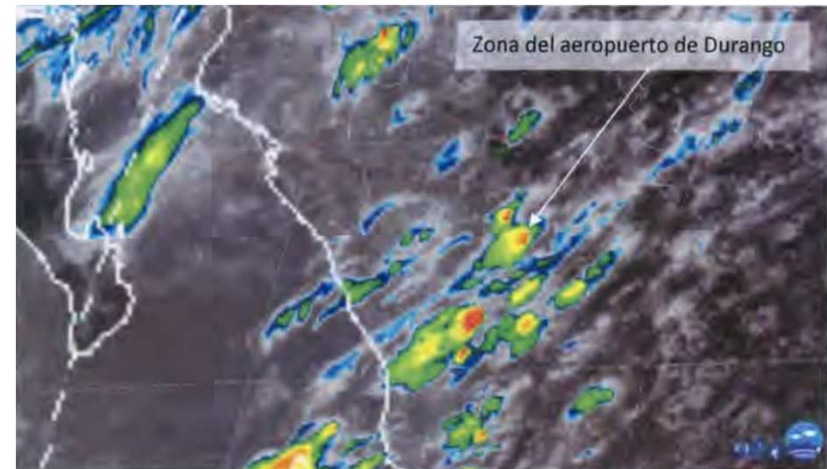
Dispatch 14:41	METAR 15:18	SPECI 15:22
Wind	010° @ 5kt	070° @ 3kt	110° @ 23kt
Horizontal Visibility	10 miles	7 miles	0 miles and VV000
Weather	Broken sky @ 2,500ft AGL Cumulonimbus	Thunderstorms Rain Broken sky @ 2,000ft AGL Cumulonimbus	Thunderstorms Rain

TWR: gives authorization to takeoff with wind 090° @ 20kt (15:22).

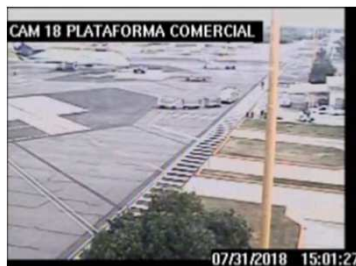
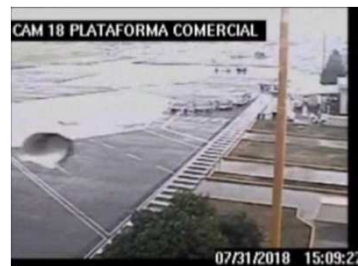
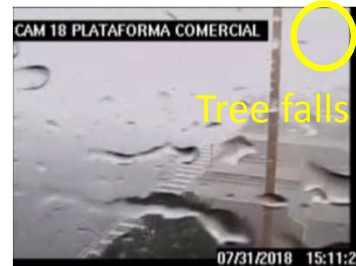
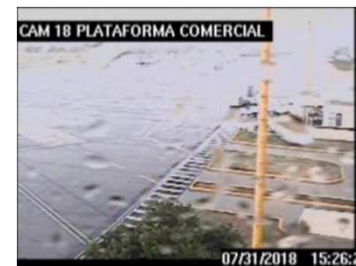
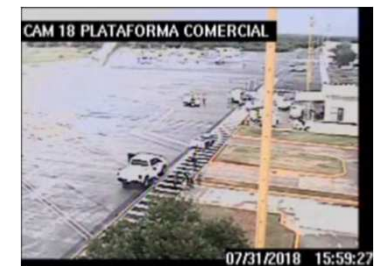
Heavy rain time was **15 min.**

Aircraft pushback

Rain starts

Heavy rain

Rain ends

PAX start arriving back
