# Facts & Fixes

Fuel Nozzle Leaks

Controlled flight into terrain

Smoke in the cockpit

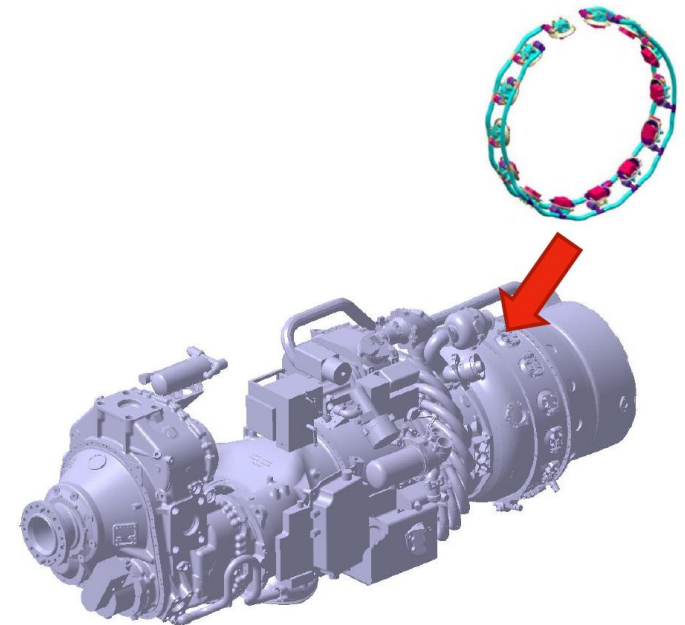
- Reported events
  - Reported **Fuel Nozzle Leaks**: 3 in 2009, 5 in 2010, 7 in 2011
    - All of them led to Engine Fire Warning
    - Some of them were actual Engine Fire
- Investigation showed:
  - Maintenance issue (**wrong torque** applied)

- Design modifications & Support
- Modification of the design
  - 2014: Phase 4
    - Modified fuel nozzle adapters installation
    - Metal conical gasket on new or modified fuel nozzle adapters
  - 2017: New Design
    - Fuel Nozzle change during Overhaul / Hot Section Inspection visits
- Maintenance & Operational visits with PWC
  - On the Job training for fuel nozzle installation

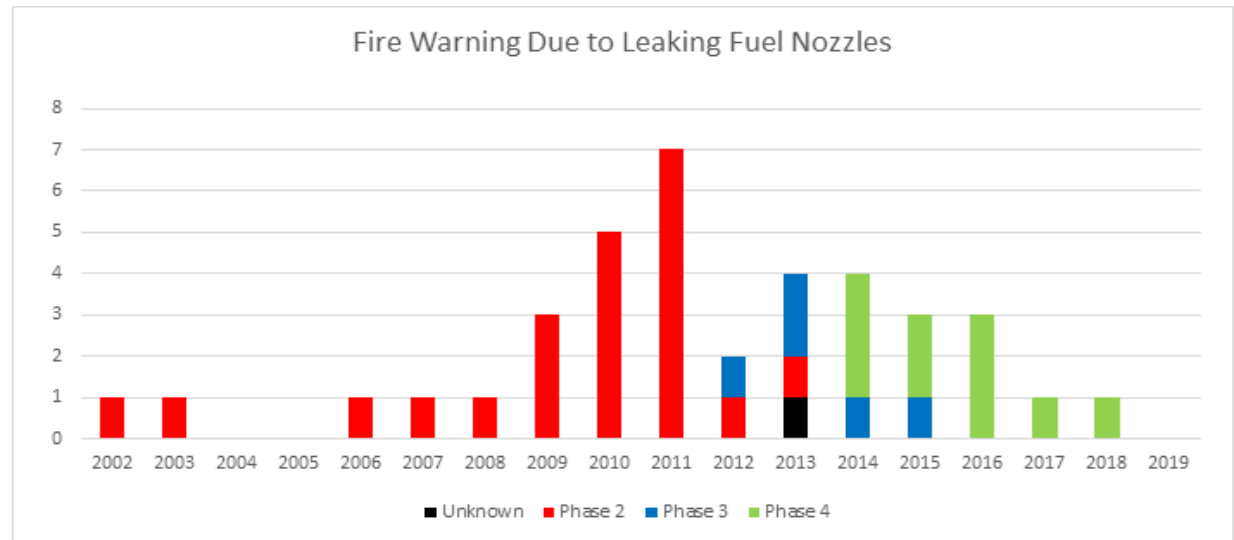
Number of events per year and per phase

- Conclusion
- Phase 2: 22 events
- Phase 3: 5 events
- Phase 4: 10 events

- New Design:
  - No leak reported with this design
  - Times x 7 between removal
  - Whole fleet retrofitted by May 2021

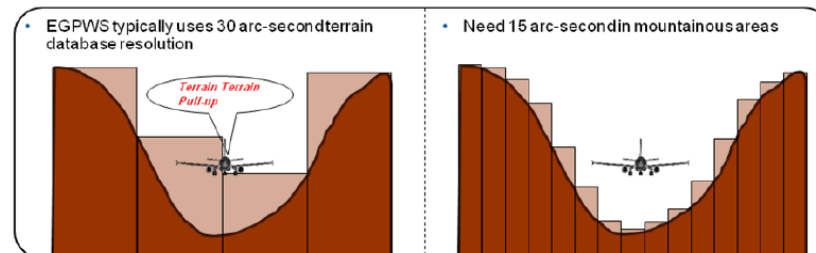
EGPWS was not provided with the high-resolution terrain data

Some pilots had experiences that the EGPWS warning became active in a condition not appropriate. These experiences led to the pilot behavior of pulling the EGPWS circuit breaker to eliminate nuisance of EGPWS warning that considered unnecessary

- Training for pilots with highlight of Situational Awareness, visual guidance and the Basic Visual Weather Minima for Approach.
- Approach guidance to be reviewed to ensure contain correct information and easy to fly to minimize the pilot workload.
- EGWS training for maintenance engineer and flight crew
- Coordinate with the manufacturer to provide specific airports with EGPWS high resolution terrain database.
- Consider the application of Performance Based Navigation (PBN) approach to fly in area with ground-based navigation system implementation is limited.

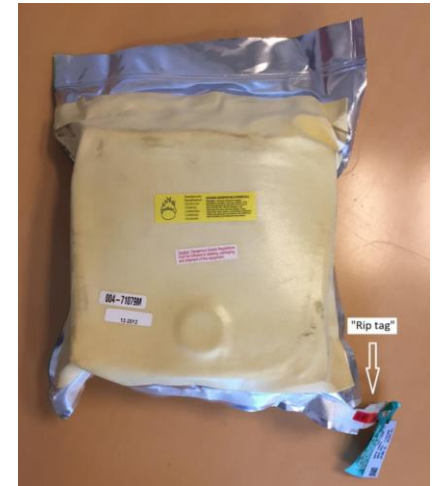
- Findings
- 19kg needed to tear open the PBE\* bag
- PBE actual opening not required in training
- No one in cabin heard Passenger Address from pilot

- Flight Crew Training (cockpit & cabin):  
actual opening of the bag + talk in oxygen Mask
- Modification of the PBE bag
