Panorama of Prevention and Investigation of Aeronautical Accidents

AERONAUTICAL ACCIDENT INVESTIGATION AND PREVENTION
CENTER - CENIPA

Col Andre Luiz MOTA - Head of Investigation Subdivision

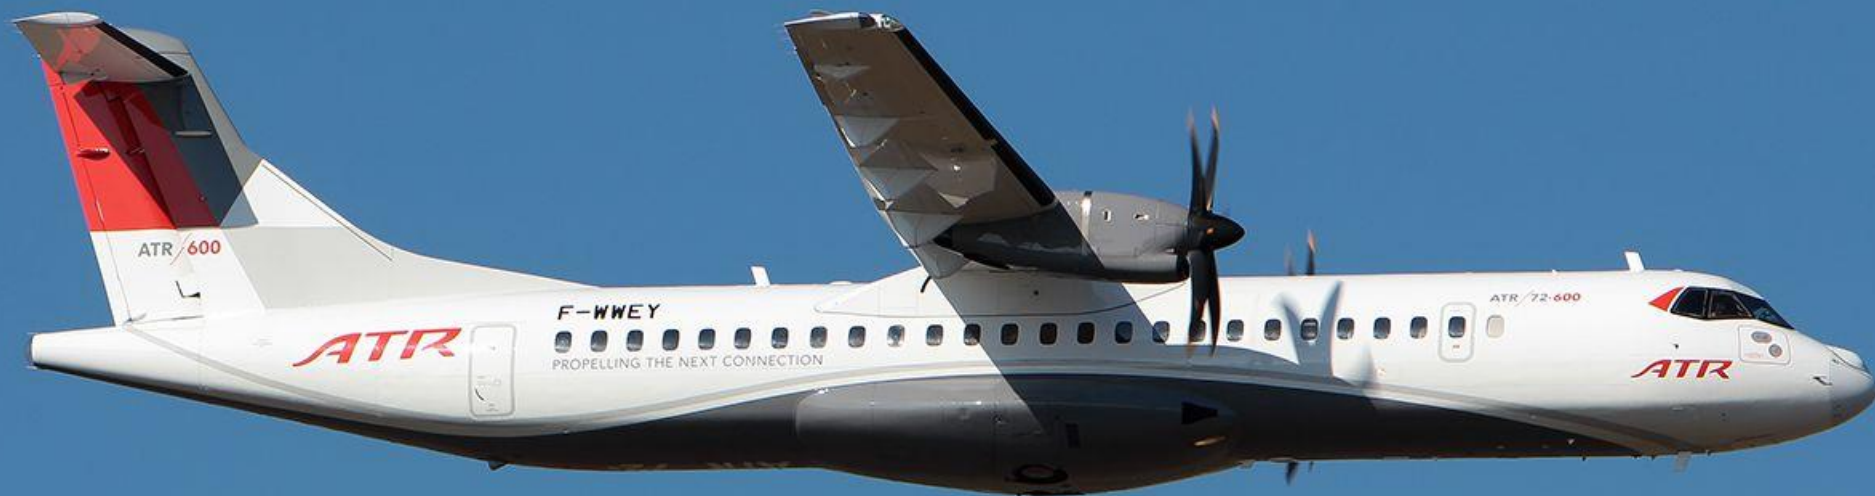
AERONAUTICAL ACCIDENT

ATR 72-212

PR-TTI

21FEV2011

- During the PR-TTI landing roll, the left main landing gear collapsed, as a result of the fracture of the AFT PIVOT PIN (D61000 SN 25). According to the aircraft manual, the entire landing gear must be overhauled after every eight-year period or 18,000 cycles.

- According to the pin maintenance manual there was no plan for any type of machining in the pin section transition region. The resulting inadequate machining finish in the region served as a facilitator for the onset of the fatigue process in the pins.
- Despite the prescriptions contained in the maintenance company's MPI, there was no participation and/or supervision by any of its professionals. This fact, jeopardized the safety of the flight.
- In the case of the outsourced companies, the required methods, techniques and parameters were not observed for the reasons previously commented, namely: lack of manuals, as well as lack of skill and knowledge in relation to the characteristics of the maintenance of certified aeronautical products.

- The last point* in the chain of events leading to the accident (*active failure) was the nonuse of the manufacturer's manuals in some stages of the overhaul of the LEFT MAIN LANDING GEAR ASSEMBLY (PN D23189000-19 SN MN170), in particular in the services performed in the AFT PIVOT PIN (D 61000 E1 SN 25). However, before this active failure, a series of actions had functioned as latent conditions.

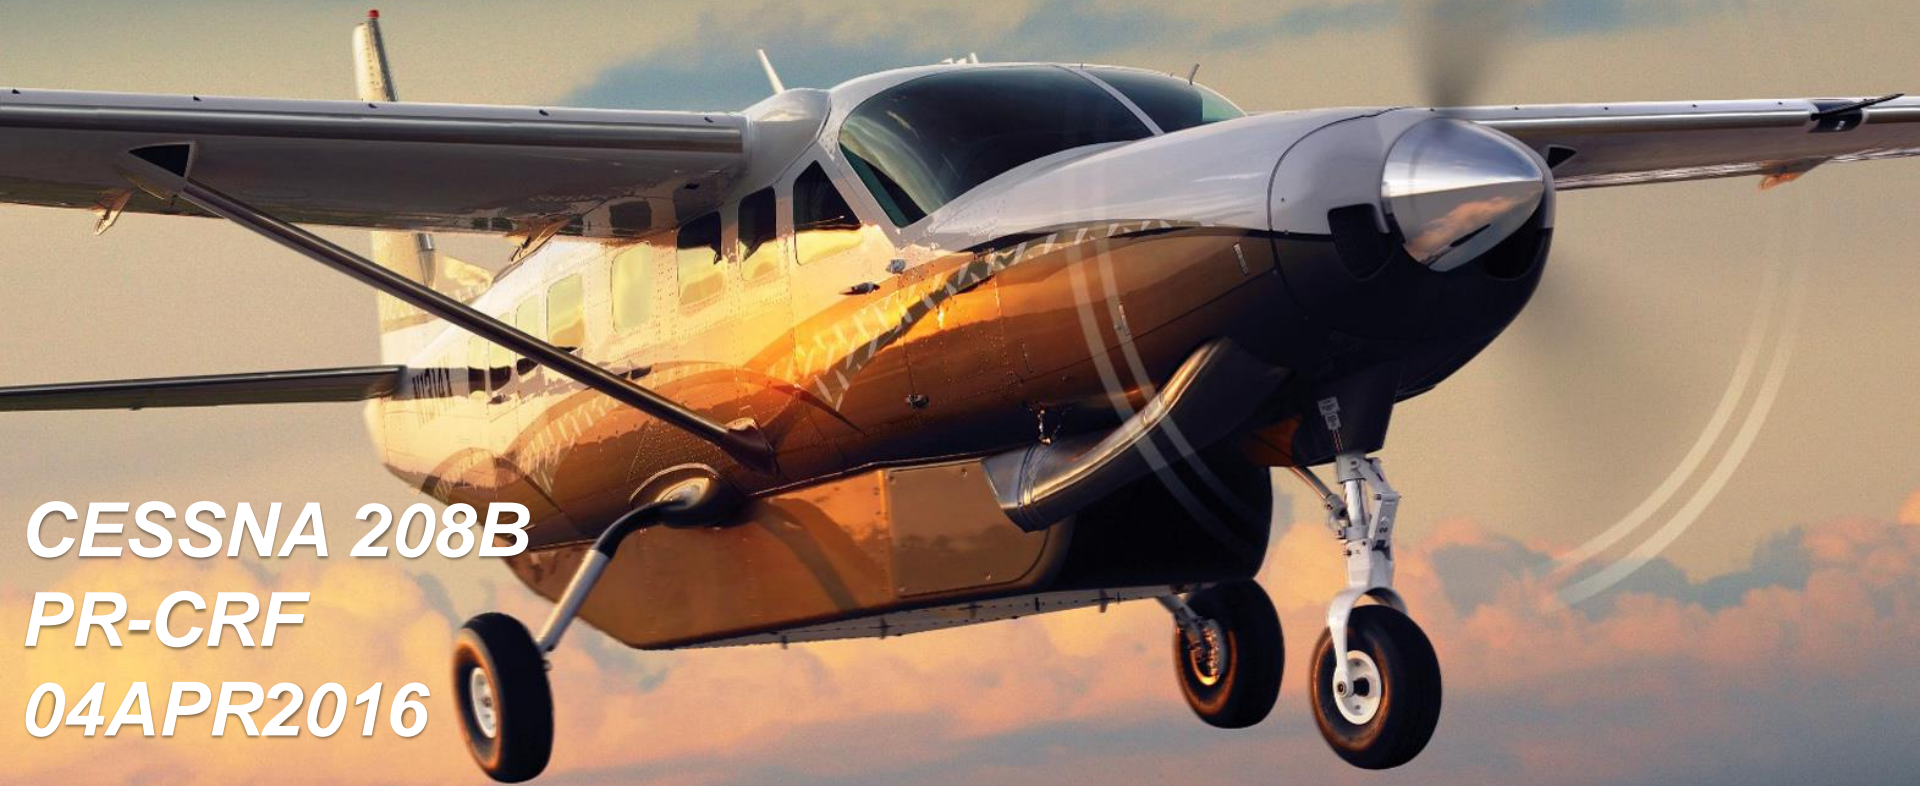
AERONAUTICAL ACCIDENT

CESSNA 208B
PR-CRF
04APR2016

- According to the report presented by DCTA to the investigators, the high working pressure of the fuel in the transfer tube caused a displacement from its housing, since the latch plate that was supposed to hold it and to avoid its movement was deformed.
- Thus, the instant the seal ring approached the entrance of the body of that injector nozzle, a fuel leak occurred, since that seat had a conical shape.
- As the pressure in the power line decreases, the engine nozzles cease to function, resulting in loss of power.
- The displacement of the transfer tube was possible because the igniter cable wire, at the 4 o'clock position, had been anchored on its latch plate. When the wire was pulled too far, it lifted and deformed this plate.
- As a result, the fuel transfer tube has been free to move from its correct working position.

- Thus, the deformation of the latch plate of the transfer tubes, which allowed its displacement, probably occurred during the execution of this safety wired. It was characterized the inadequacy of maintenance services performed on the aircraft as a contributing factor to the failure of the PR-CRF engine.
