Abnormal runway contact during takeoff

- Abnormal runway contact during takeoff under heavy rain at Durango Airport, Mexico

EMB-190 31/Jul/2018

Embraer Air Safety Department

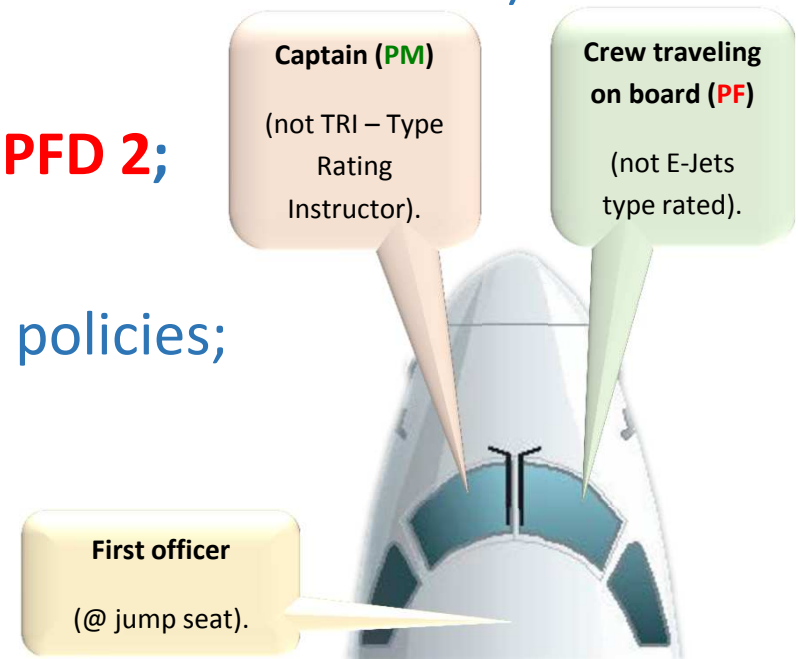
... and the probable cause:

- LOSS OF CONTROL AT THE FINAL PHASE OF THE TAKEOFF RUN (...) DUE TO A **DECREASE OF SPEED AND LIFT.**
- The investigation authority issued recommendations to the operator, local aviation regulator, ATC and airport administrator.

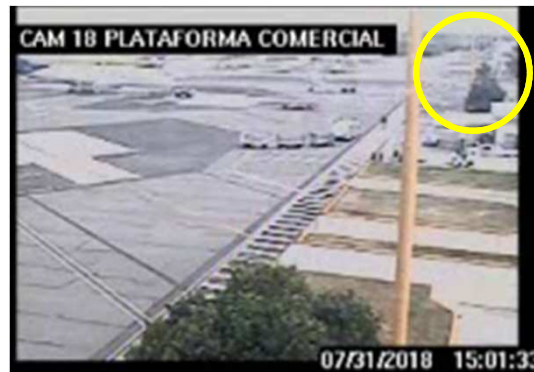
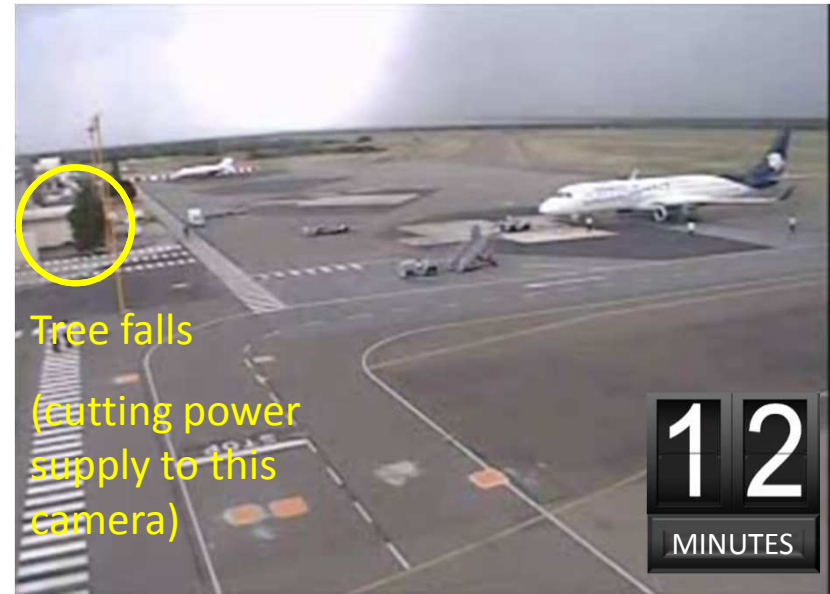
Surveillance cameras:

Heavy rain time was **15 min.**

Aircraft pushback

Rain starts

Heavy rain

Rain ends

PAX start arriving back

8 min

2 min

15 min

33 min

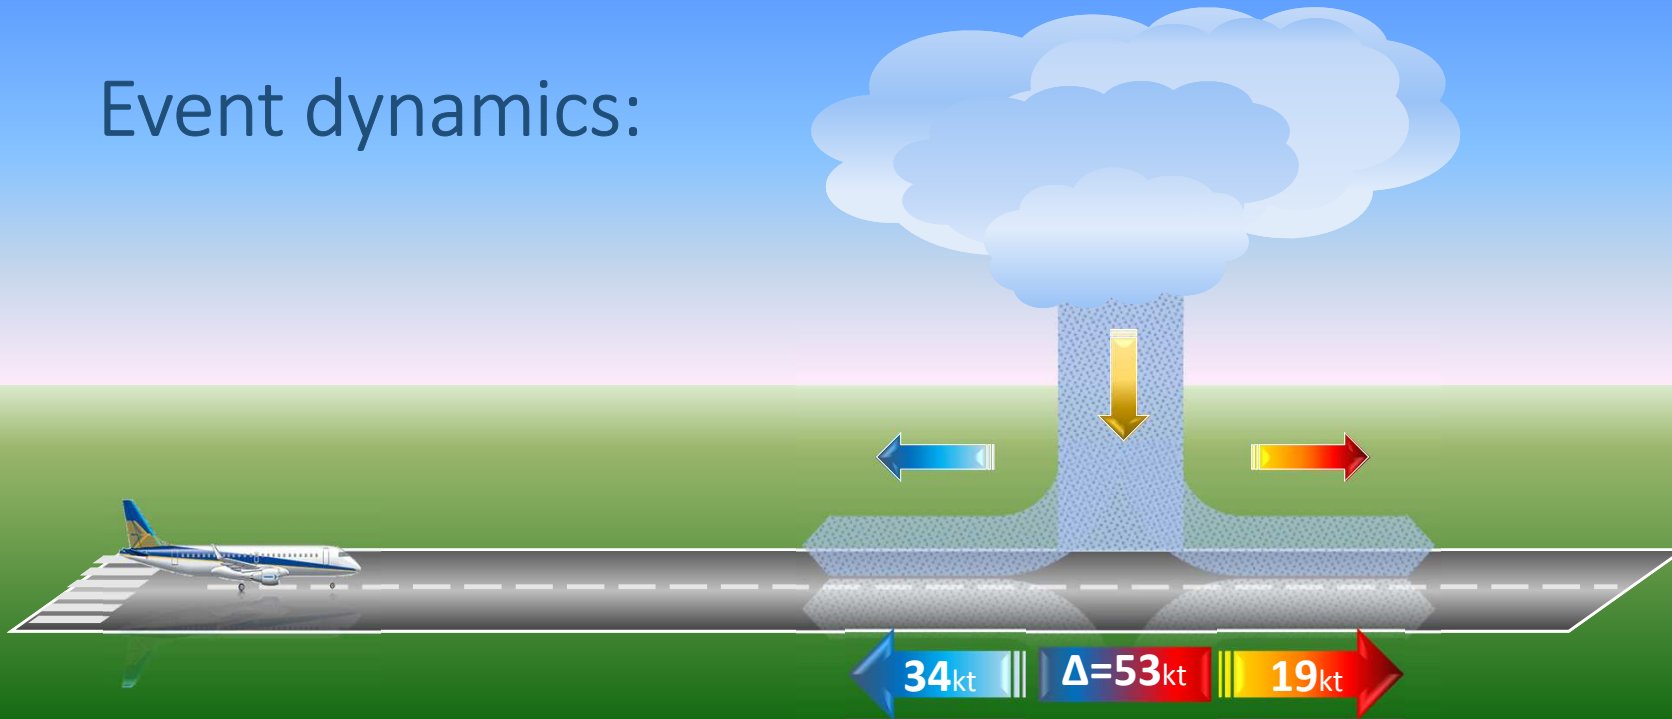
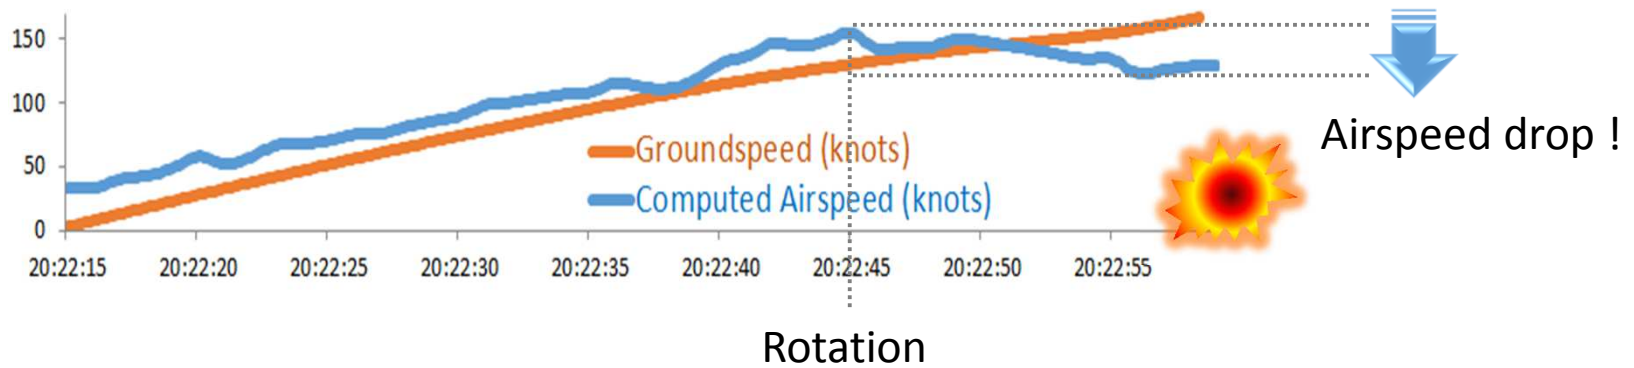
Event dynamics:

Airspeed #1 #2 Groundspeed
