# Facts & Fixes

Fuel Nozzle Leaks

Controlled flight into terrain

Smoke in the cockpit

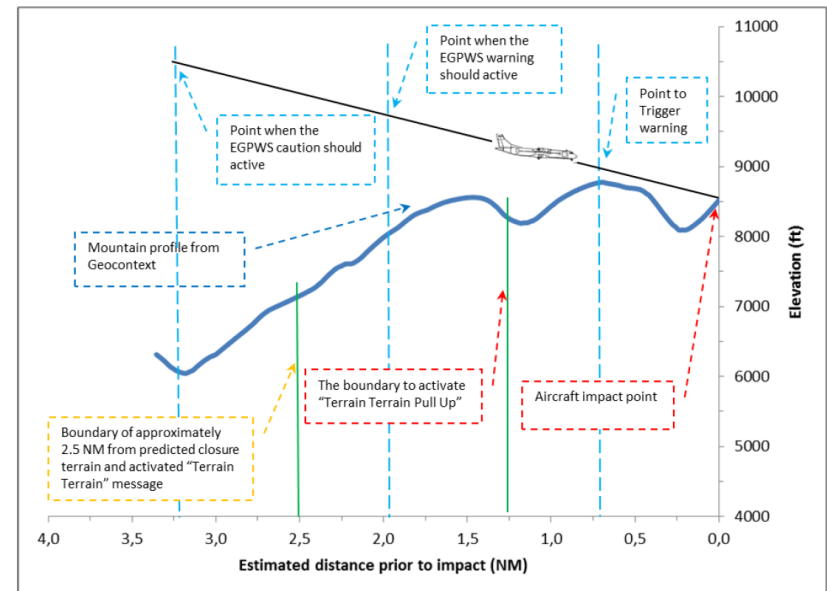
- Reported events
  - The pilot made first contact with Aerodrome Flight Information Services (AFIS), reporting cruising at 11500 feet
  - The AFIS controller acknowledged the message and instructed the pilot to report when overhead the airport
  - the pilot had extended the flap and landing gear in preparation for landing
  - Aircraft impacted the terrain at elevation approximately 8,300 feet

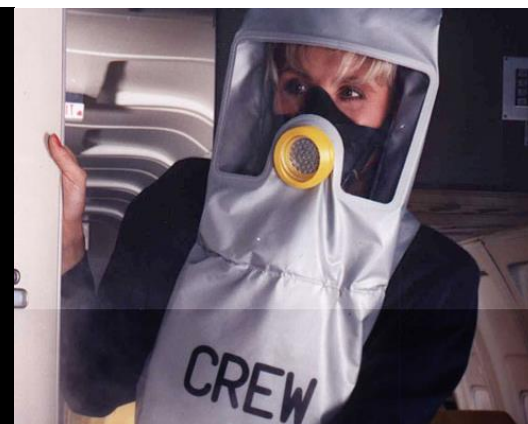
- 1min after takeoff, eng 1 failure, smoke in the cockpit and in the cabin
- Cockpit crew donned their oxygen masks, secured eng1, declared emergency, landed 4 min after takeoff, evacuated safely
- 1 cabin crew put on her smoke hood, the other **could not**
