# Use of Reactive Information to Enhance PA-RAST Safety Recommendations

PA-RAST/21 Meeting

Presented by: Brazil

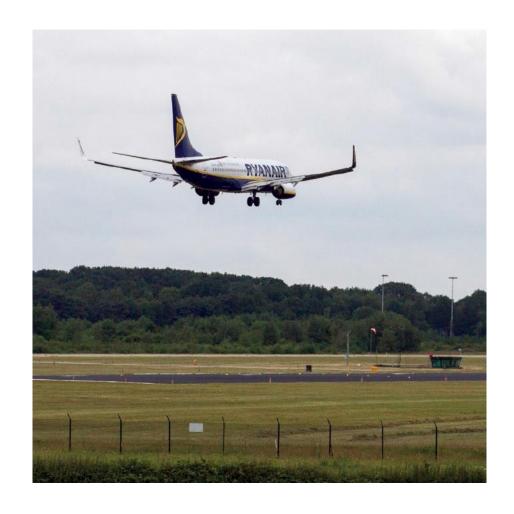
The general belief is that false Glide Slopes invariably occur at regular intervals from the normal 3 degree angle. In addition, the general view is that a warning is given in the cockpit before the aircraft crosses a False Glide Slope. The identified incidents with different aircraft types seem to indicate differently.
